## **San Ildefonso Pueblo River Maintenance Priority Site**

### **Geomorphic Trends Assessment Final Report**

**Department of the Interior  
Bureau of Reclamation  
Albuquerque Area Office**

**September 2005**

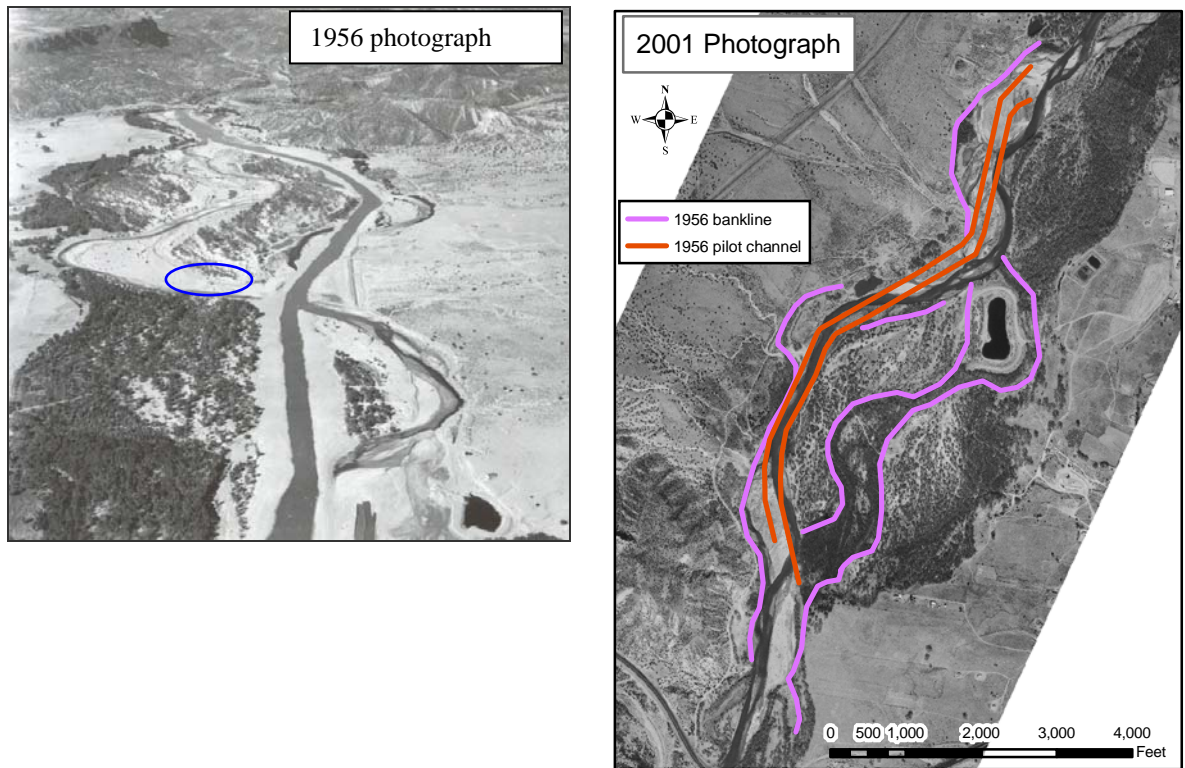
Figure 3: The 1956 photograph (left) shows the channel re-alignment of the Rio Grande (looking downstream) on the Pueblo of San Ildefonso (Bureau of Reclamation photo archives); blue oval designates the approximate location of the fishing pond. The right figure shows an approximate graphical view of the re-alignment overlain on the 2001 aerial photographs (right).

By 1956, the 1935 side channel appears to have become the main Rio Grande channel (Figure 3). However, a channel re-alignment project in this reach moved the main channel west, back to the approximate location of the main channel in 1935. In this re-alignment project, several small bends were also abandoned; the created channel in the 1956 project was much less wide than the old channel and was much straighter. Although no documentation are available, we assume that the fishing pond was built shortly after this project was completed; we also assume that the Kellner Jetty Jacks that are present in the reach (Figure 4) were also emplaced during this channel floodway construction. Based on field observations, several of the jack lines appear to have been placed parallel to the approximate location of the 1956 pilot channel. Some of the jetty jacks have subsequently 'fallen' into the Rio Grande (Figure 4).

Historically, a prominent side channel flowed across the current location of the fishing pond between 1935 and 1956 (Figures 2 & 3). Project photographs from 1956 show that this side channel (Figure 3) had become the prominent channel before a re-alignment project of the Rio Grande occurred in this area. Although the new channel was constructed straight, migrating bends have recently formed upstream from the fishing pond, increasing the bankline sinuosity. The spoil piles upstream from the pond appear to be adding curvature to the main channel by deflecting the thalweg around them. This increased curvature may be enhancing the focus of the river against the east bank and thus enhancing the channel migration process.

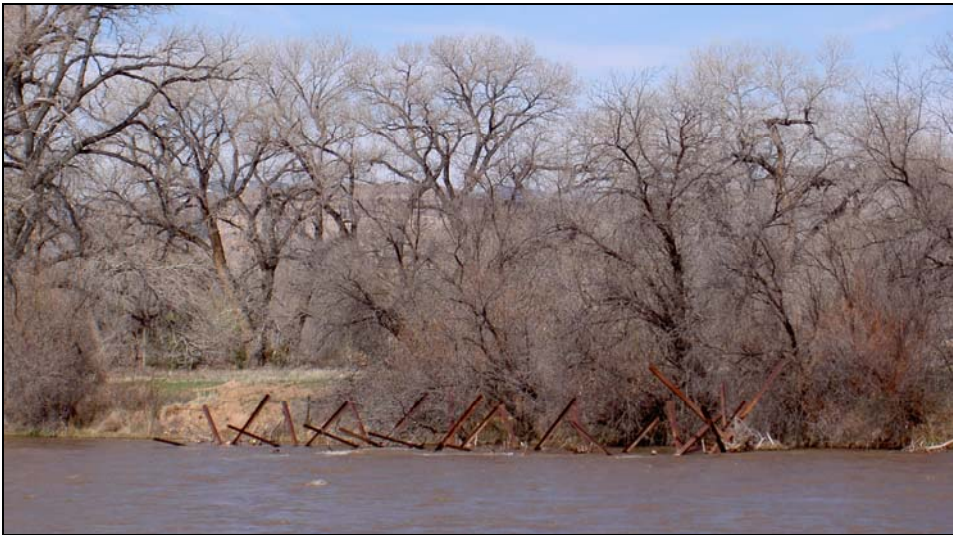
Figure 4: Jetty line that has 'fallen' into the Rio Grande at the Pueblo of San Ildefonso.

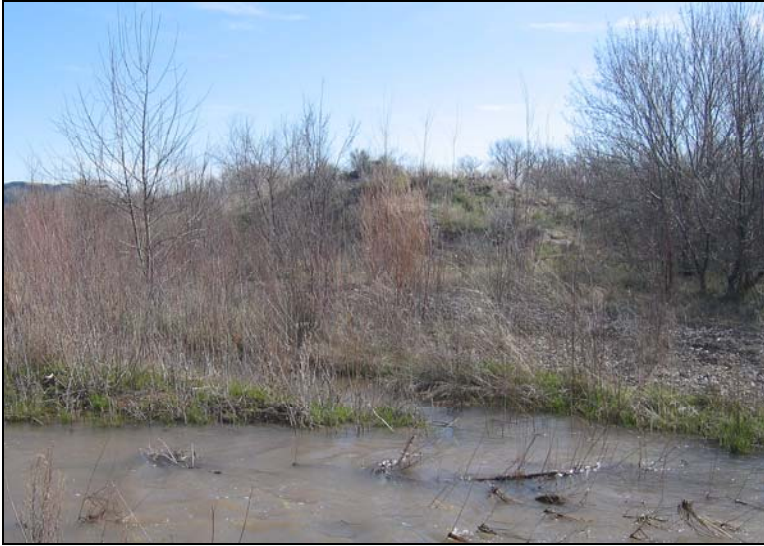
Figure 5: Spoil pile at the confluence of the Contrayerba Canyon arroyo and the Rio Grande. The flowing water is a Rio Grande side channel to the west of the main channel.

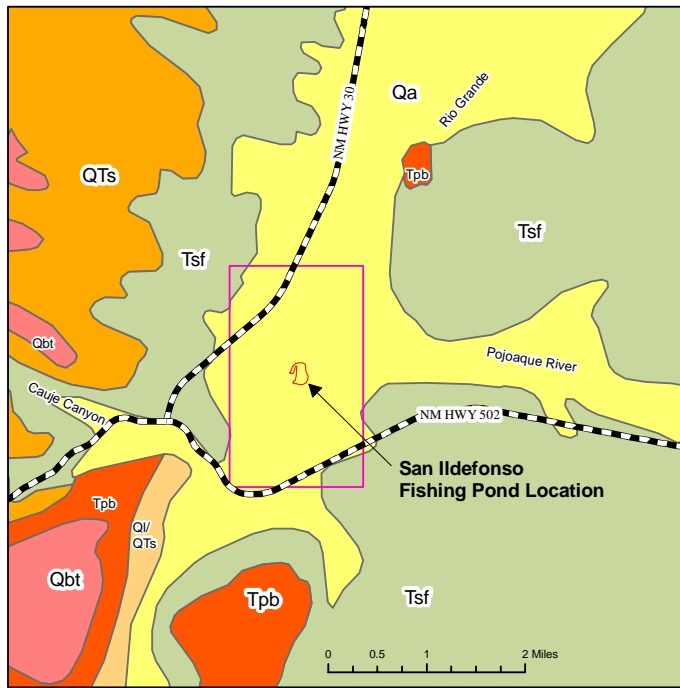
Figure 6: Close-up of the area surrounding the San Ildefonso fishing pond from the New Mexico Geologic Map (Anderson et al. 1997). **Qa** - Alluvium; upper and middle Quaternary. **QI/QTS** - Landslide deposits and colluvium within the Upper Santa Fe Group. **QTs** - Upper Santa Fe Group; middle Pleistocene to uppermost Miocene. **Qbt** - Bandelier Tuff. **Tpb** - Basalt and andesite flows; Pliocene. **TsF** - Lower and Middle Santa Fe Group; Miocene and uppermost Oligocene.

The San Ildefonso Fishing Pond Priority Site lies on Quaternary alluvium deposited by the Rio Grande and its nearby tributaries (Figure 6, Anderson et al. 1997). The study site is located within the Espanola Basin, a well documented graben within the Rio Grande Rift zone. This basin is geologically controlled and centered at the Rio Chama/Rio Grande confluence (Kelley 1978), which is upstream from the study site. As with other Rio Grande grabens, the valley is filled primarily of fluvial and arroyo derived sediments including sand and gravel (Anderson et al. 1997; and Kelley 1978). Although the basin was likely intermittently blocked by large landslides located immediately downstream in White Rock Canyon, the Rio Grande currently drains the basin through White Rock Canyon; the canyon is approximately 1,000 feet deep and predominantly filled with the large Pleistocene age landslide deposits and to a lesser degree, fluvial sediments (Dethier 1997).

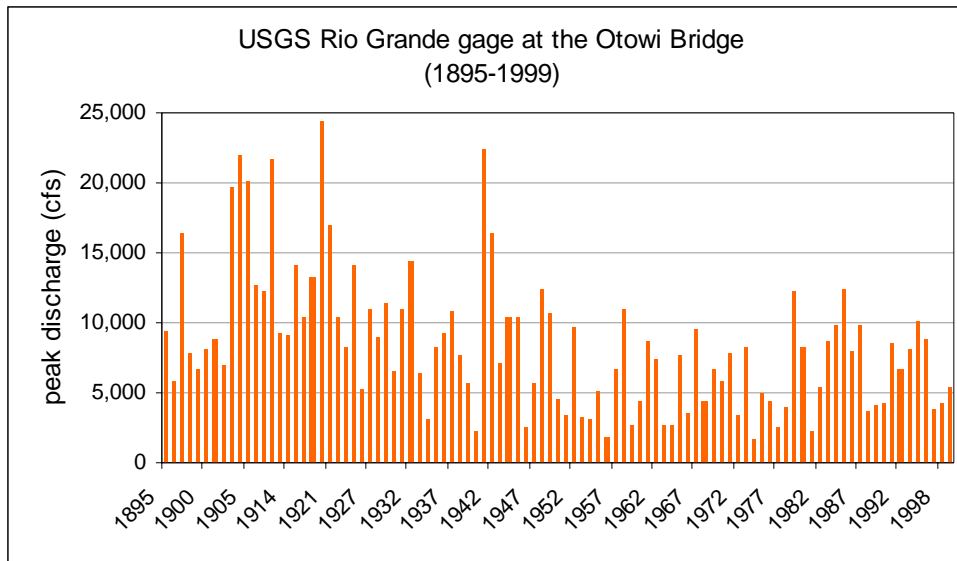
Figure 7: Peak flow data for the USGS Rio Grande gage at the Otowi Bridge, NM (Hydrosphere, 2000).

Less than 2 miles downstream from the study site is the USGS Rio Grande gage at the Otowi Bridge (Otowi gage) which provides discharge data (1895-present) and suspended sediment data collected since 1955. Peak flow data (Figure 7) show that the last large flows (>15,000 cfs) were in the early 1940s, with the highest peak recorded in 1920 at 24,400 cfs. These data also show that after 1942 the magnitude of the peak flows passing the Otowi gage are significantly smaller than prior to 1942. In fact, a simple recurrence analysis of the peak flow data shows that the 2-yr event prior to 1942 (1895-1942) was 10,400 cfs, but after 1942 is only 5,800 cfs (Table 2), almost a 50% reduction in discharge.

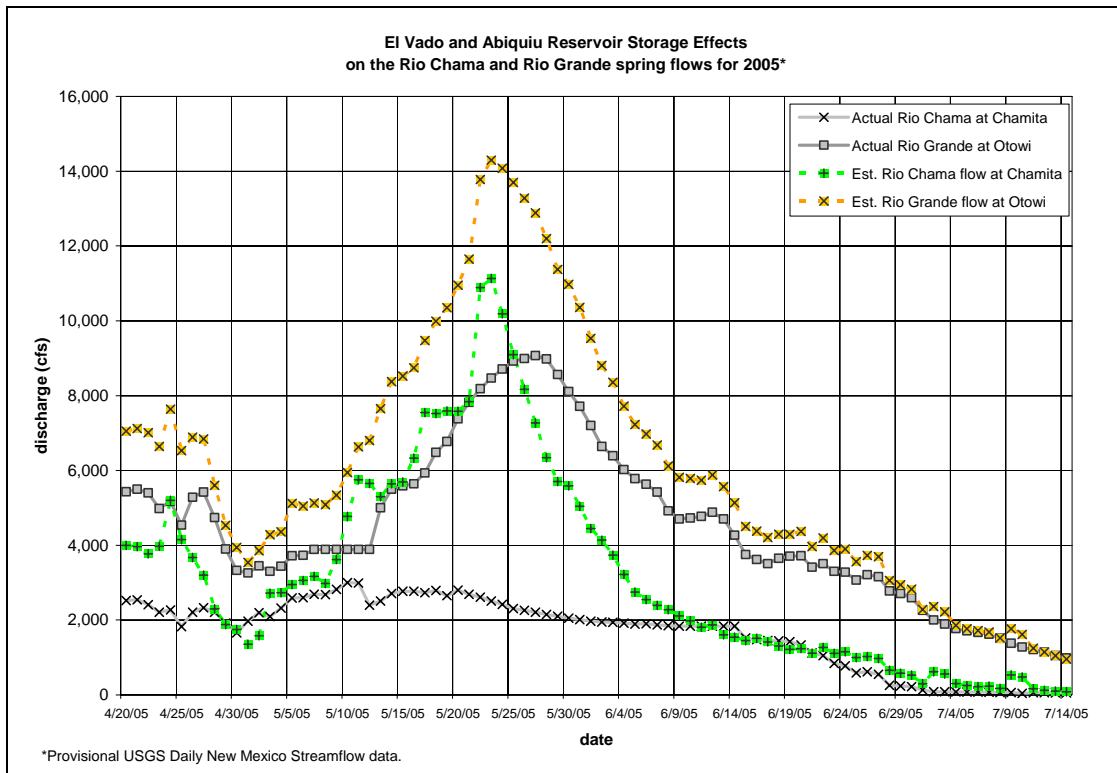
Figure 8: An illustration of the effects of flood storage at El Vado and Abiquiu Reservoirs on the Rio Chama and Rio Grande hydrographs (daily flow values). The estimated Rio Chama flow at Chamita is a rough estimate of the peak runoff in 2005 if reservoirs had not stored water during the runoff event; the estimate adds together the discharge that was released during runoff (actual Rio Chama at Chamita flow) and the discharge that was stored in El Vado and Abiquiu Reservoirs. The estimated Rio Grande flow at Otowi combines the estimated Rio Chama flow at Chamita with measured Rio Grande flows.

The 'cause' for this reduction in peak flows can be attributed to two main processes: climate change (a severe drought in the 1950s) and flood water storage in El Vado and Abiquiu Reservoirs on the Rio Chama. A well documented drought occurred in the 1950s throughout the state of New Mexico (Scurlock 1998). A drought pattern is present in the Otowi gage data during the 1950s and into the 1960s as few spring runoff peaks surpass the 2-year event level (Figure 7). Just prior to and during the drought event, two dams were built on the Rio Chama, a major tributary to the Rio Grande which joins just upstream of the study site: El Vado dam (1934/5) and Abiquiu dam (1963). El Vado and Abiquiu dams were built primarily for flood control by Reclamation and the Army Corps of Engineers. As seen in the 2005 spring runoff, spring peak flows can be dramatically reduced through a combined storage at these dams/reservoirs (Figure 8). If flood water storage had not occurred in 2005 on the Rio Chama, the runoff would have peaked at over 11,000 cfs on the Rio Chama at Chamita and 14,000 cfs on the Rio Grande at Otowi Bridge. This size event at Otowi Bridge is estimated to have a return period of less than 5 years for the 1895-1942 period, but greater than a 10-year event for the 1943-1999 period. Although the 1950s drought is the likely main 'cause' for the reduced peak flows in the 1950s, flood operations on the Rio Chama (a.k.a., reservoir storage of peak flows) is the likely 'cause' of a continuation of the reduced peak flows after the drought ended in the 1960s. Consequently, the peak flow record after 1942 will be used to estimate channel conditions and extrapolate physical trends into the future for this study.

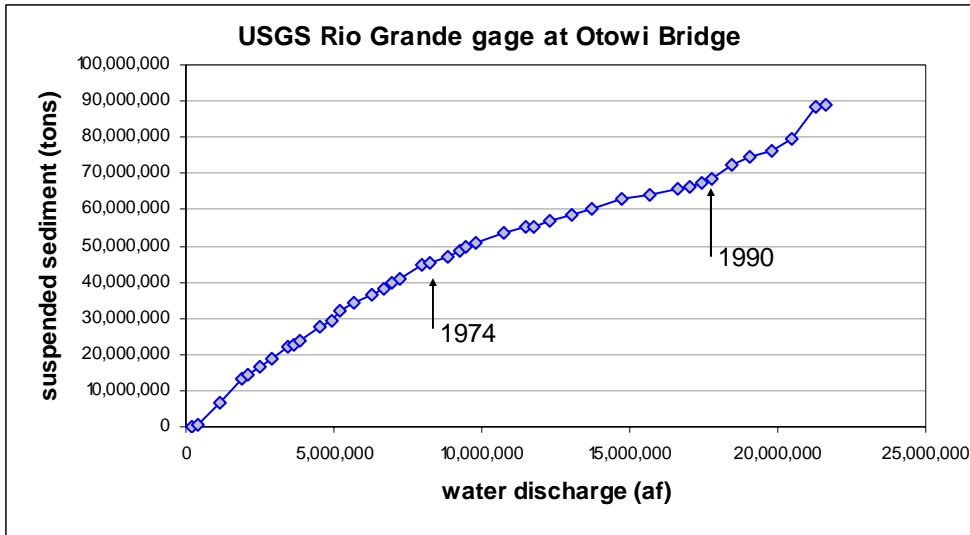
Figure 9: Cumulative suspended sediment data compared to water discharge for the USGS Rio Grande gage at the Otowi Bridge, NM (Hydrosphere, 2000).

The suspended sediment data collected at the Otowi gage shows that concentration of suspended sediment also changed, however the change was a reduction in concentration between 1974-1990, with a return to previous levels after 1990. Between 1974 and 1990 the amount of suspended sediment measured at the Otowi gage decreased to less than half of the historic levels (Figure 9 and Table 3). Since 1990, the data show that sediment concentrations have increased to historical levels. Although the Abiquiu dam on the Rio Chama obviously influence peak flows, these operations which began in 1963 do not appear to be substantially influencing the suspended sediment concentration.

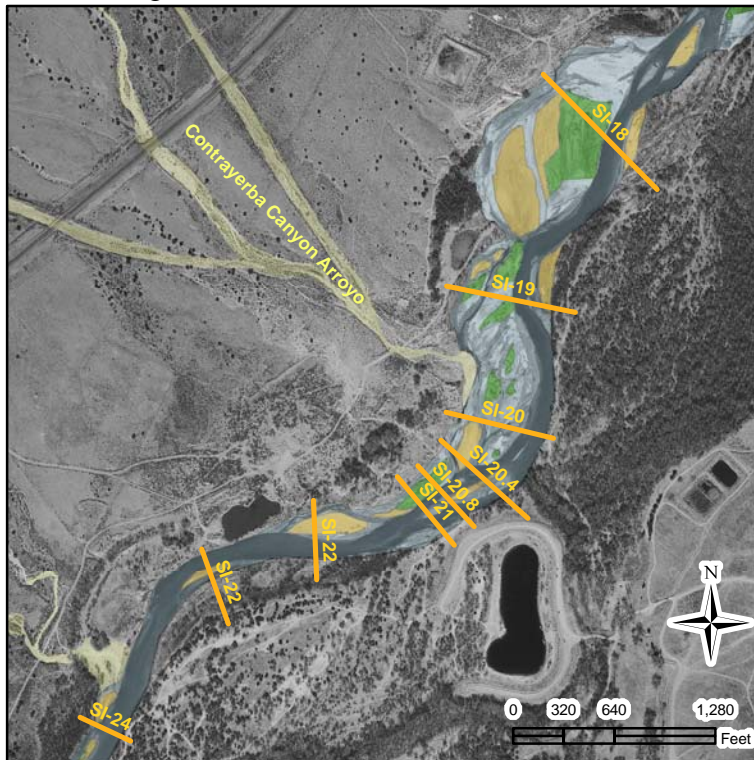
Figure 10: Reclamation cross section locations on the Rio Grande on the Pueblo of San Ildefonso.

The current channel dimensions were estimated using cross section data collected in February 2005 (Figure 10). These data were modeled in the U.S. Army Corps of Engineering HEC-RAS (2004) for both the 2-year return flow (5,800 cfs) and the 5-year return flow (9,700 cfs). The HEC-RAS model was calibrated for water surface elevations in February when the data were collected, and then again for observed water's edge data collected in May 2005 at a discharge of approximately 6,200 cfs. During both calibrations, the Manning's 'n' value was 0.028.

The rate of bend migration was estimated using both photography and cross section data. Bench-marked cross section data (Figure 10) are available for several years: 1995, 1996, 1998 and 2005. These data show that the bend has migrated approximately 25 feet in the last ten years between elevations 5506-5508 feet (Figure 15). The average rate of this eastward bank migration is 2.5 ft/yr (Table 8). Unfortunately the actual apex of the bend is upstream from SI-20, and more bank erosion is present at this location; therefore, 2.5 ft/yr should be used as a minimum bank retreat rate for this bend. Based photo data, the maximum bankline retreat is 90 feet since 1993 (~11 ft/yr) with 70 feet since 1996 (14 ft/yr).

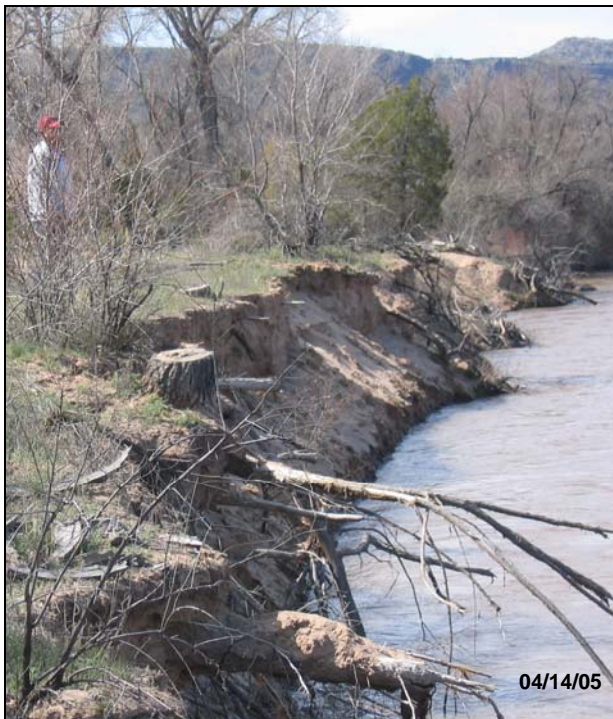
Figure 13: Close-up of the actively eroding Rio Grande bankline at Bend #1 (Terrace #2).

Terrace 2 is 4-5 feet tall and appears to have been the riparian floodplain in the 1930s; the migrating bend is eroding this terrace. This surface may have been a partially dissected island prior to 1935 as surface depressions of 1-2 feet were observed on it. The main depression occurs at the east side of the Terrace 2 boundary with Terrace 1; it was likely a historic side channel that separated this terrace from the floodplain. Other depressions/apparent side channels occur throughout the terrace; some of these abandoned side channels feed into the old 1956 main channel near the fishing pond (Terrace 3). Terrace 2 pre-dates 1935 (>70 years) as it was already vegetated at that time; it is composed of

mostly well packed sand, and silt sediments (Figure 13) and covered with cottonwoods, saltcedar, and other vegetation.

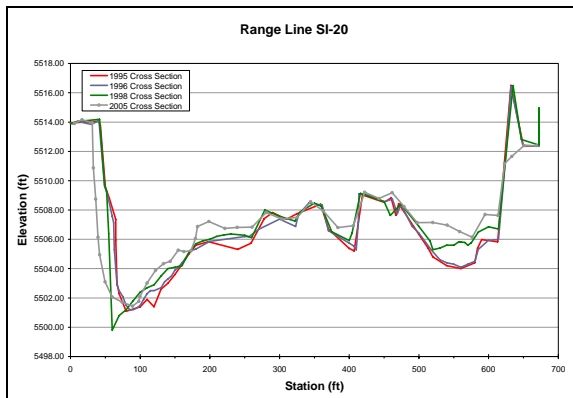
Figure 15: Cross section survey data SI-20 from 1995 through 2005.

Immediately upstream from the east bank bend is the west bank bend that range line SI-19 intersects. This bend has migrated 86 feet since 1996 (Figure 15 and Table 8). The average rate of this westward bank migration is 9.5 ft/yr (Table 8). The material eroded is recently deposited river sediments that are likely more easily eroded than the terrace sediment on the east bank bend downstream. Although these sediments have not been sampled, field observations are consistent with the cross section data (Figure 15) that shows the sediments form relatively vertical banks and appeared to be composed of silt, sand and gravel.
